EXTERIOR

GENERAL : 1 ½ Story Rancher House. Walls appear to be plumb

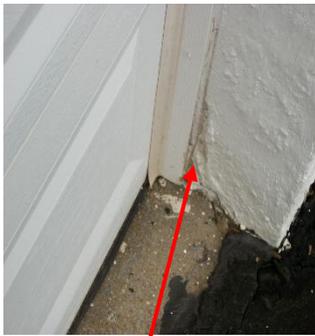
OBSERVATIONS : : FUNCTIONAL : The inspected system or item was found to be functional at the time of the inspection. There were no indications of eminent failure. **One area of the stucco that has been repaired at right garage door frame [See Picture]**

Stucco has been repaired

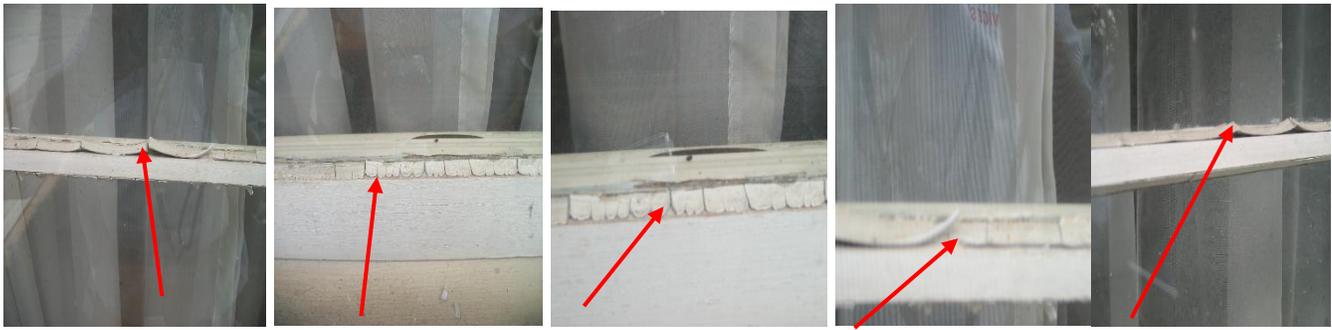
OBSERVATIONS : FUNCTIONAL : The inspected system or item was found to be functional at the time of the inspection. There were no indications of eminent failure. **Even though the wood windows are operational, they hard open and closing. All the wooden windows need glazing and re-painted. [See Pictures]**

GLAZING NEEDS REPLACED

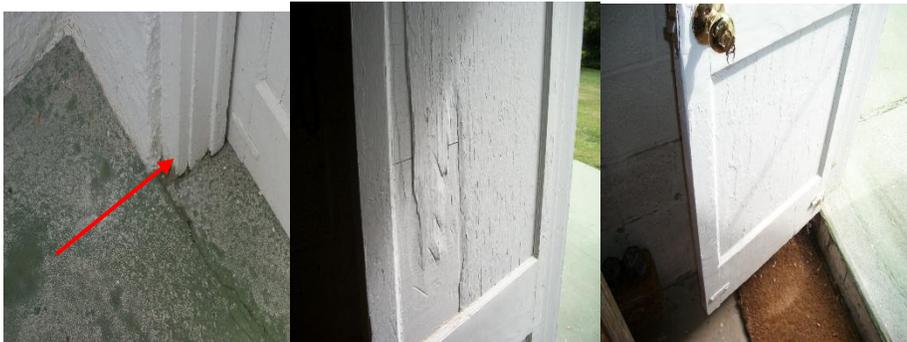
EXTERIOR DOORS: Exterior doors are wood doors. Both have newer storm door with plungers attached. The passage door to the garage has some wet rot at the bottom of the door frame. [See Picture] Also the door itself is in bad shape needs replaced. [See Pictures]

Wet rot in door frame

Rotted door

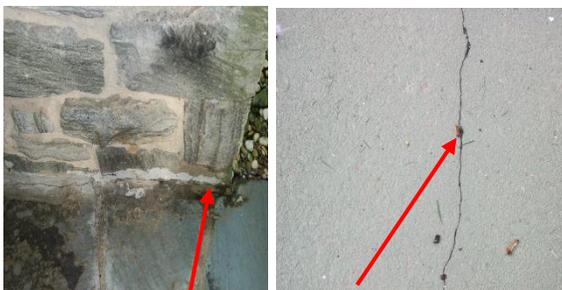
OBSERVATIONS : FUNCTIONAL : The inspected system or item was found to be functional at the time of the inspection. There were no indications of eminent failure. Concrete slab on the back has some small cracks in it. [See Pictures]

Flag stone porch has need some repairs to loose mortar [See Picture]

Loose mortar

Back slab has a small crack

MAINTENANCE TIPS: Porches and patios can be treated with a water sealer to help prevent excessive wear on the concrete. This can be done every other year.

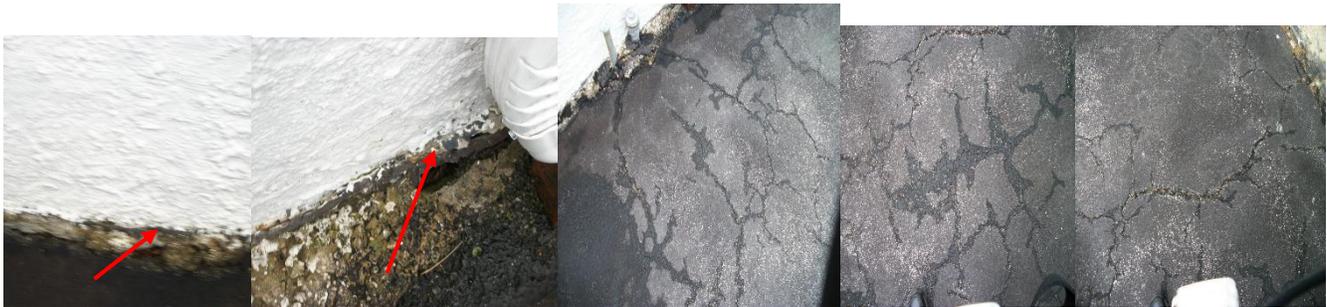
Holes in blacktop against foundation

Cracks in blacktop

MAINTENANCE TIP: Small cracks in driveway black tops can be sealed with a liquid black top sealer available at Home Depot for around \$10.00. Use a large putty knife to smooth out the liquid tar you have applied. The larger cracks you need to clean out the larger pieces of black top and to prepare to seal, using the sealed that comes in caulking tubes, which is thick, do the same procedure as above. The tubes are around \$4.00 per tube.

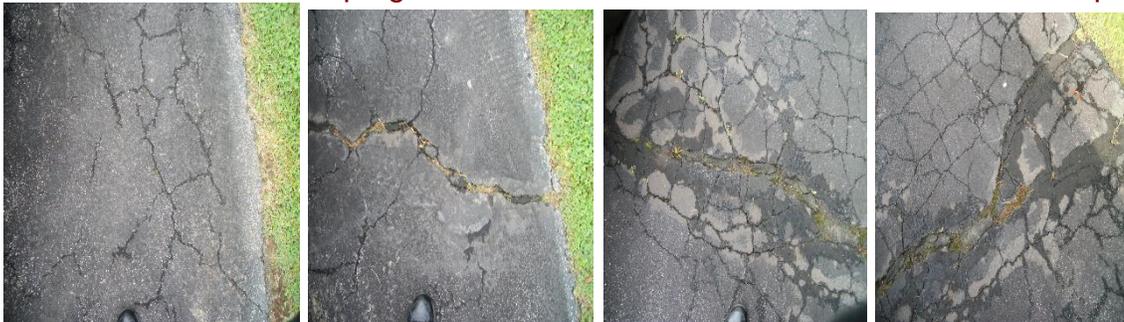
CRACKS IN BLACKTOP VARIOUS AREAS

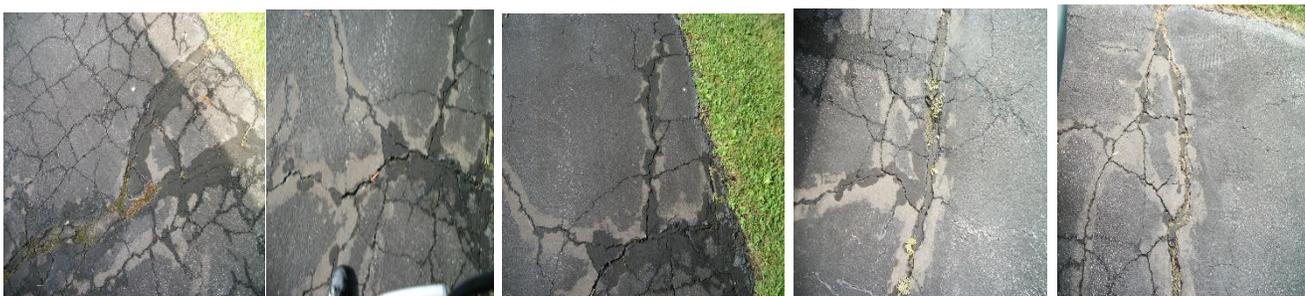
CRACKS IN BLACKTOP VARIOUS AREAS

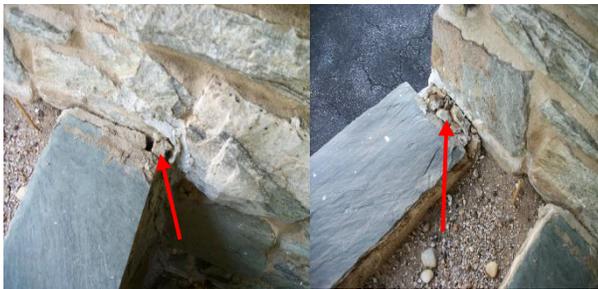
Mortar needs repaired

OBSERVATIONS : FUNCTIONAL : The inspected system or item was found to be functional at the time of the inspection. There were no indications of eminent failure. **Retaining wall where it meets the house needs to have mortar repaired.**

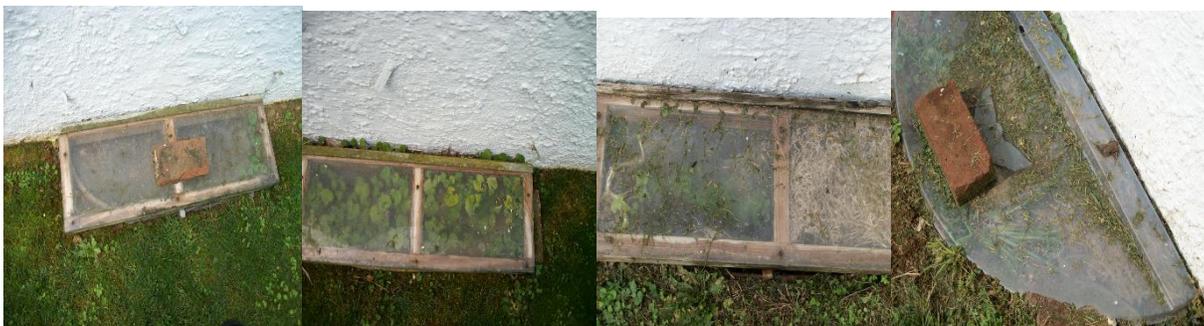
THESE WINDOW WELLCOVER ARE NOT SERVICING THE PURPOSE VEGATAION IS GROWING IN THEM, RPLACE WITH PROPER COVERS

OBSERVATIONS :: **ACTION REQUIRED** : Items marked action required appear to be in need of immediate attention. Delay in maintenance or repair of these items may result in a dramatic shortening of the life expectancy of the item, have immediate negative effect on other related systems, or be a potential safety hazard. Often action is advisable on these items prior to or shortly after moving into the home. *Need to put new proper window well covers on them.*
